1858-1864 Clearbrooke Wind Mitigation

Wind Mitigation Inspection Report

By: Fair Wind Inspections Inc.

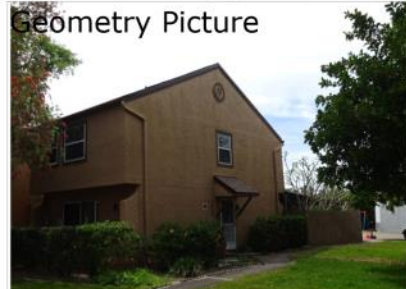
Geometry Picture

Roof Geometry: Non-Hip
 Total Non-Hip: N/A Total Perimeter: N/A
 Less Than 2:12: N/A Total Area: N/A

Gable end walls and/or non-hip features are greater than 10% of total perimeter
