# Clearbrooke Townhomes Wind Mitigation 1865-1871

## Wind Mitigation Inspection Report

Date/Time: 1/22/2024 10-12 PM  
First Name: Clearbrooke  
Last Name: Townhomes  
Contact Number:  
Contact Number:  
E-mail:  
Address: 1865-1871 Clearbrooke Dr  
City: Clearwater  
State: FL  
Zip: 33760  
County: Pinellas  
Advertiser: Previous Customer  
Referred By:

Year Built: 1978  
Square Foot:  
Evacuation Zone: C  
Distance from Bay/Gulf: Less than 1 mile  
Exposure Category: B  
Stories: 2  
Inspected By: Kevin  
Price: 90  
Home Notes:

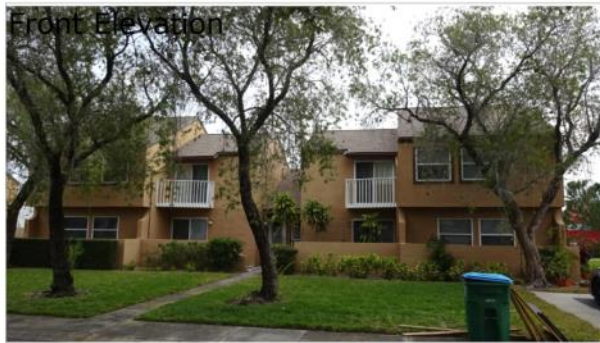
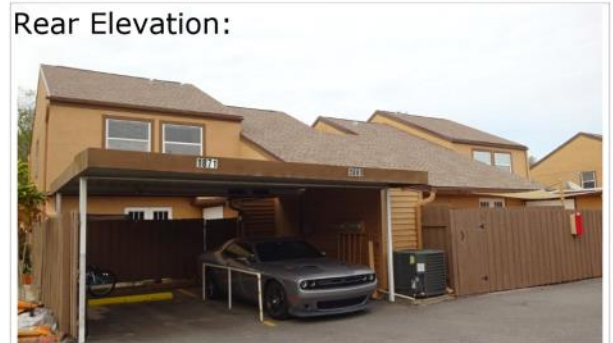
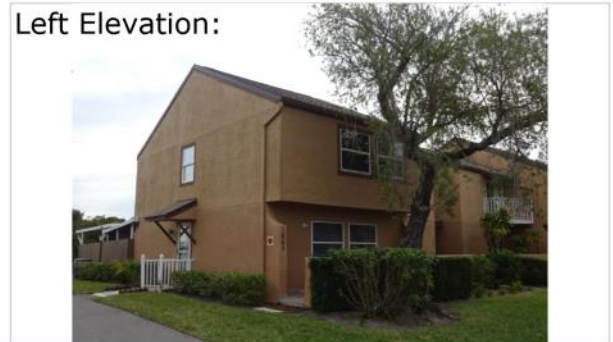
Date Replaced: Oct 30, 2023  
Permit With: City of Clearwater  
Permit Number: EBP-23-18066  
Covering: Shingles

Roof surface is in good condition

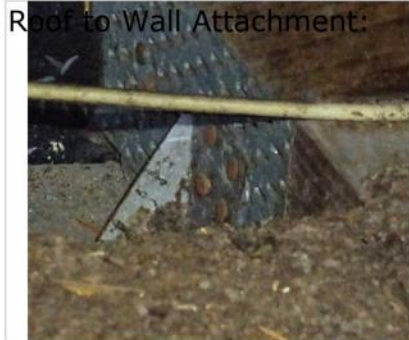
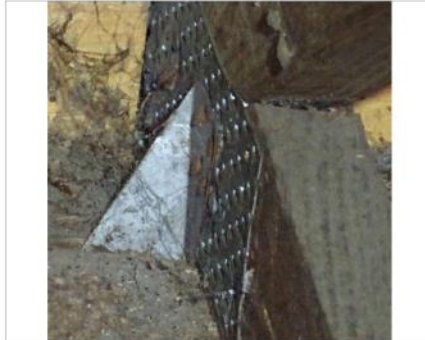
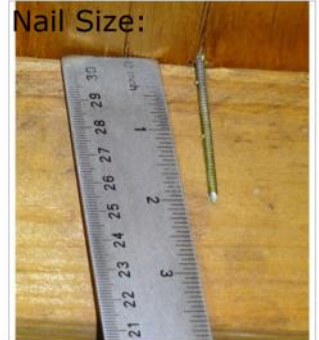
Clip Type:   
 Nails Per Clip:
