# 1800 Clearbrooke Wind Mitigation (Clubhouse)

## Wind Mitigation Inspection Report

By: Fair Wind Inspections Inc.

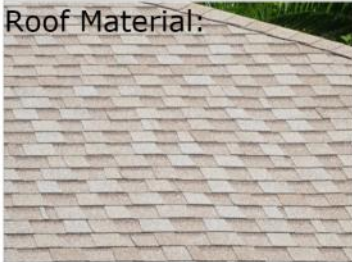
Roof Material:

Date Replaced: March 29, 2015  
Permit With: Pinellas County  
Permit Number: PER-H-CW15-03060  
Covering: Shingles

Roof surface is in good condition

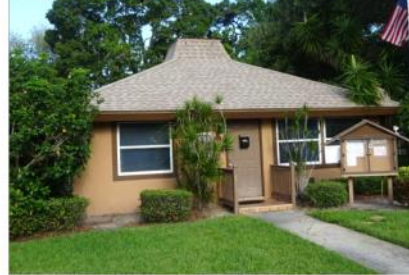
Geometry Picture

Roof Geometry: Hip  
Total Non-Hip: 0  
Total Perimeter: 100%  
Less Than 2:12: N/A  
Total Area: N/A

Entire roof structure is hip in shape

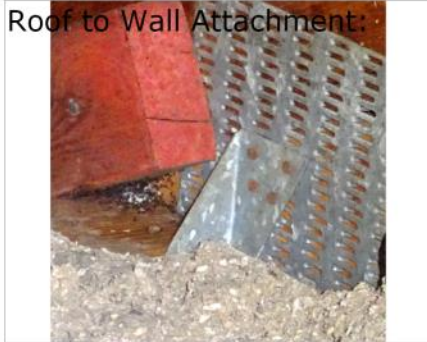
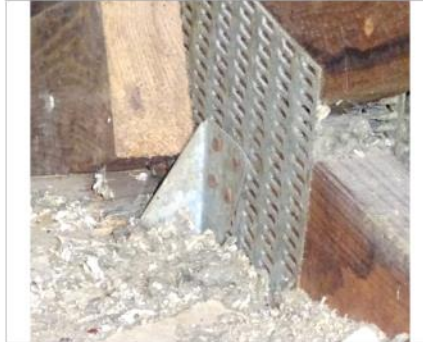
Roof to Wall Attachment:

- ☒ B. Clips
  - ☒ Metal connectors that do not wrap over the top of the truss/rafter, **or**
  - ☒ Metal connectors with a minimum of 1 strap that wraps over the top of the truss/rafter and does not meet the nail position requirements of C or D, but is secured with a minimum of 3 nails.

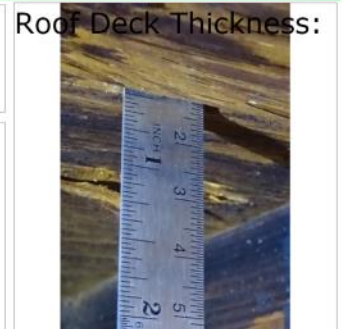
Roof Deck Thickness:

- ☒ C. Plywood/OSB roof sheathing with a minimum thickness of 7/16" inch attached to the roof truss/rafter (spaced a maximum of 24" inches o.c.) by 8d common nails spaced a maximum of 6" inches in the field. -OR- Dimensional lumber/Tongue Groove decking with a minimum of 2 nails per board (or 1 nail per board if each board is equal to or less than 6 inches in width). -OR- Any system of screws, nails, adhesives, other deck fastening system or truss/rafter spacing that is shown to have an equivalent
