1801-1807 Clearbrooke Wind Mitigation

Wind Mitigation Inspection Report

By: Fair Wind Inspections Inc.

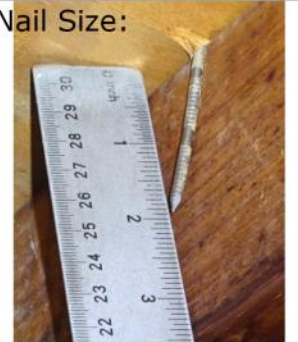
Roof to Wall Attachment:

Nail Size:

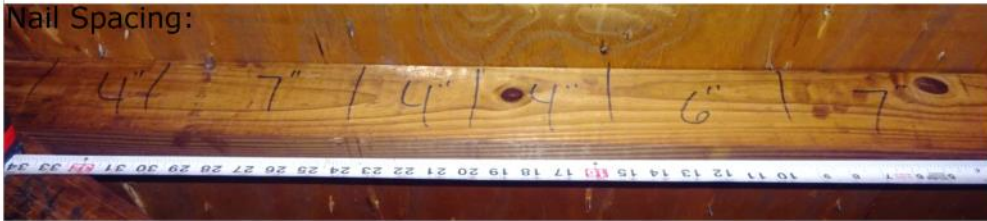
Underside of roof is in good condition

Roof Deck Thickness:

Nail Spacing:

Recommenations: Recommendations for this home would be to install a hurricane shutter system over the windows and doors for maximum protection as well as (possibly) increased savings. (ALL GLAZED OPENINGS a.k.a. items with glass in them must be protected or impact rated).
