1802-1808 Clearbrooke Wind Mitigation

Wind Mitigation Inspection Report

By: Fair Wind Inspections Inc.

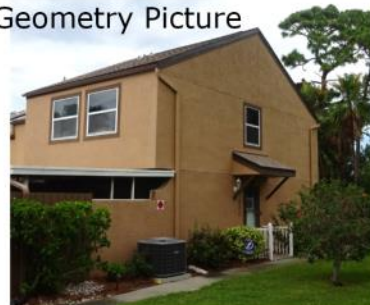
Geometry Picture

Roof Geometry: Non-Hip
Total Non-Hip: N/A Total Perimeter: N/A
Less Than 2:12: N/A Total Area: N/A

Gable end walls and/or non-hip features are greater than 10% of total perimeter

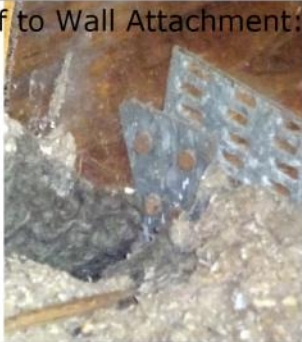
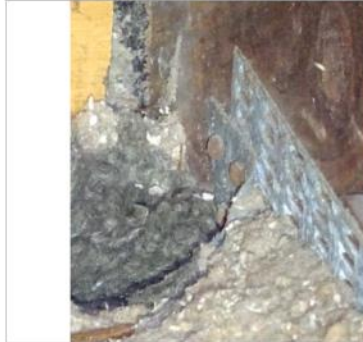
Roof to Wall Attachment:

- ☒ Secured to truss/rafter with a minimum of three (3) nails, **and**
- ☒ Attached to the wall top plate of the wall framing, or embedded in the bond beam, with less than a 1/2" gap from the blocking or truss/rafter and blocked no more than 1.5" of the truss/rafter, and free of visible severe corrosion.

- ☒ B. Clips
 - ☒ Metal connectors that do not wrap over the top of the truss/rafter, **or**
 - ☒ Metal connectors with a minimum of 1 strap that wraps over the top of the truss/rafter and does not meet the nail position requirements of C or D, but is secured with a minimum of 3 nails.
