# 1809-1815 Clearbrooke Wind Mitigation

## Wind Mitigation Inspection Report

By: Fair Wind Inspections Inc.

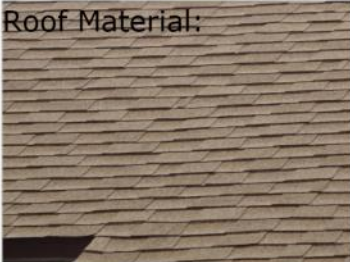
Roof Material:

Date Replaced: July 10, 2017  
Permit With: Pinellas County  
Permit Number: PER-H-CW17-08332  
Covering: Shingles

Roof surface is in good condition

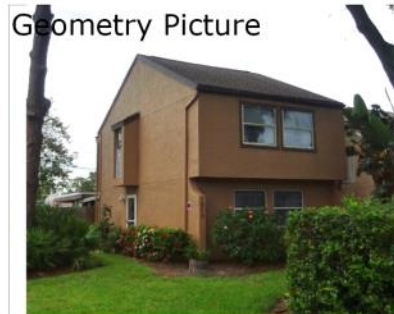
Geometry Picture

Gable end walls and/or non-hip features are greater than 10% of total perimeter

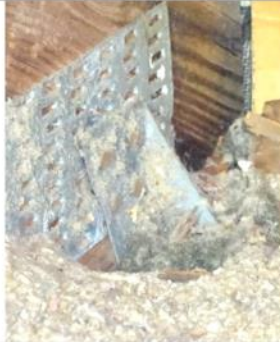
Roof to Wall Attachment:

- ☒ B. Clips
  - ☒ Metal connectors that do not wrap over the top of the truss/rafter, **or**
  - ☒ Metal connectors with a minimum of 1 strap that wraps over the top of the truss/rafter and does not meet the nail position requirements of C or D, but is secured with a minimum of 3 nails.

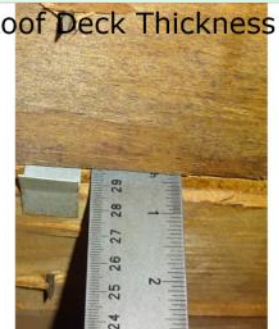
Roof Deck Thickness:

Underside of roof is in good condition

- ☒ C. Plywood/OSB roof sheathing with a minimum thickness of 7/16" inch attached to the roof truss/rafter (spaced a maximum of 24" inches o.c.) by 8d common nails spaced a maximum of 6" inches in the field. -OR- Dimensional lumber/Tongue Groove decking with a minimum of 2 nails per board (or 1 nail per board if each board is equal to or less than 6 inches in width). -OR- Any system of screws, nails, adhesives, other deck fastening system or truss/rafter spacing that is shown to have an equivalent
