1810-1816 Clearbrooke Wind Mitigation

Wind Mitigation Inspection Report

By: Fair Wind Inspections Inc.

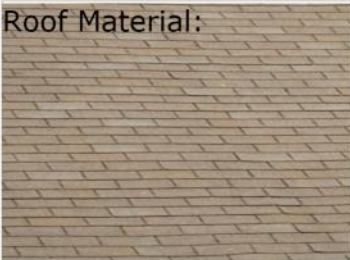
Roof Material:

Date Replaced: Unknown
Permit With: n/a
Permit Number: n/a
Covering: Shingles

Roof surface is in good condition

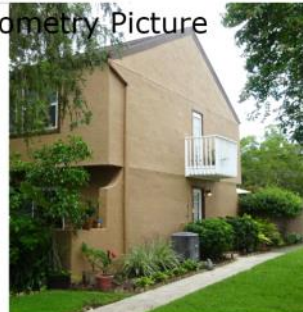
Geometry Picture

Roof Geometry: Non-Hip
Total Non-Hip: N/A Total Perimeter: N/A
Less Than 2:12: N/A Total Area: N/A

Gable end walls and/or non-hip features are greater than 10% of total perimeter

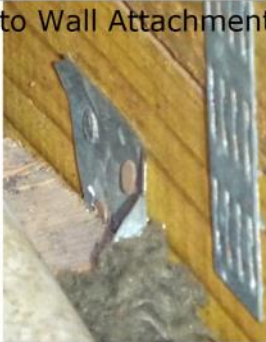
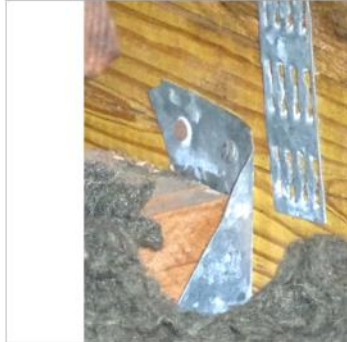
Roof to Wall Attachment:

- ☒ B. Clips
 - ☒ Metal connectors that do not wrap over the top of the truss/rafter, **or**
 - ☒ Metal connectors with a minimum of 1 strap that wraps over the top of the truss/rafter and does not meet the nail position requirements of C or D, but is secured with a minimum of 3 nails.

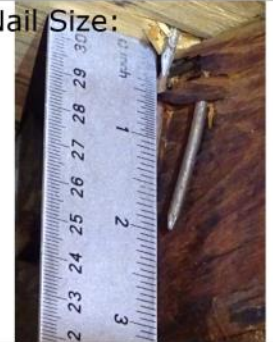
Nail Size:

Underside of roof is in good condition

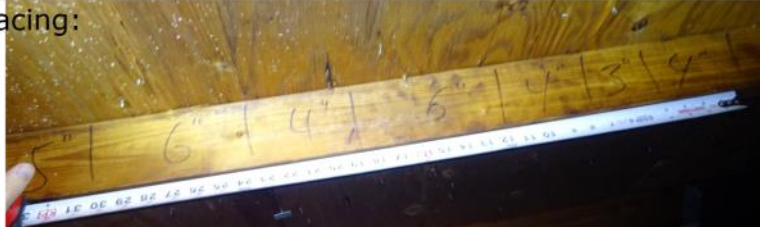
Nail Spacing:

- ☒ C. Plywood/OSB roof sheathing with a minimum thickness of 7/16" inch attached to the roof truss/rafter (spaced a maximum of 24" inches o.c.) by 8d common nails spaced a maximum of 6" inches in the field. -OR- Dimensional lumber/Tongue Groove decking with a minimum of 2 nails per board (or 1 nail per board if each board is equal to or less than 6 inches in width). -OR- Any system of screws, nails, adhesives, other deck fastening system or truss/rafter spacing that is shown to have an equivalent
