1817-1823 Clearbrooke Wind Mitigation

Wind Mitigation Inspection Report

By: Fair Wind Inspections Inc.

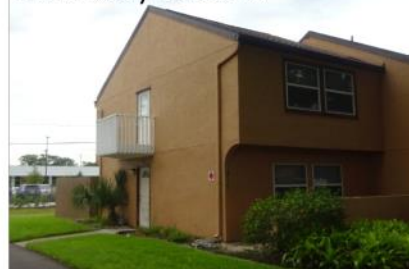
Geometry Picture

Gable end walls and/or non-hip features are greater than 10% of total perimeter

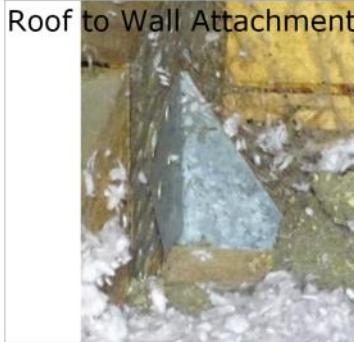
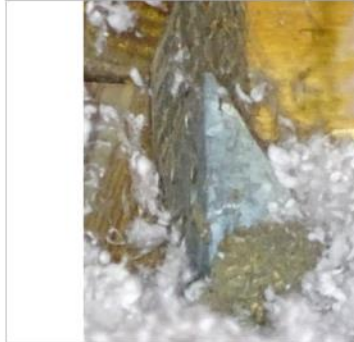
Roof to Wall Attachment:

- ☒ Secured to truss/rafter with a minimum of three (3) nails, **and**
- ☒ Attached to the wall top plate of the wall framing, or embedded in the bond beam, with less than a 1/2" gap from the blocking or truss/rafter and blocked no more than 1.5" of the truss/rafter, and free of visible severe corrosion.

- ☒ B. Clips
 - ☒ Metal connectors that do not wrap over the top of the truss/rafter, **or**
 - ☒ Metal connectors with a minimum of 1 strap that wraps over the top of the truss/rafter and does not meet the nail position requirements of C or D, but is secured with a minimum of 3 nails.
