1818-1824 Clearbrooke Dr Wind Mitigation

Wind Mitigation Inspection Report

By: Fair Wind Inspections Inc.

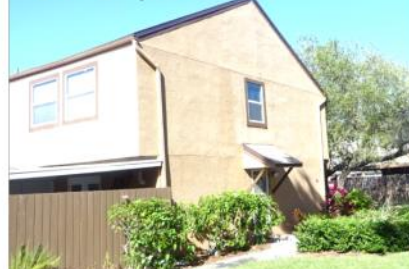
Geometry Picture

Gable end walls and/or non-hip features are greater than 10% of total perimeter

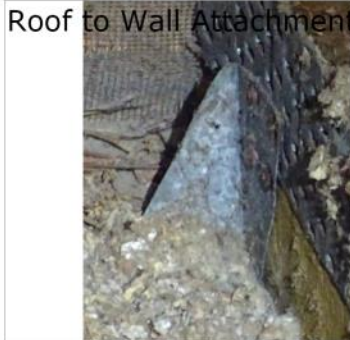
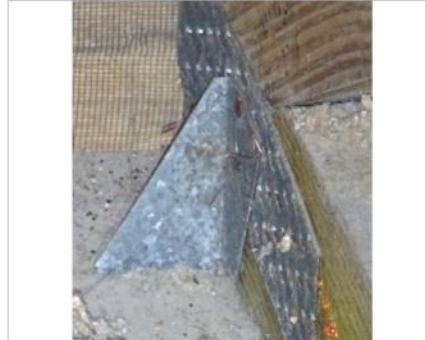
Roof to Wall Attachment:

- ☒ B. Clips
 - ☒ Metal connectors that do not wrap over the top of the truss/rafter, **or**
 - ☒ Metal connectors with a minimum of 1 strap that wraps over the top of the truss/rafter and does not meet the nail position requirements of C or D, but is secured with a minimum of 3 nails.

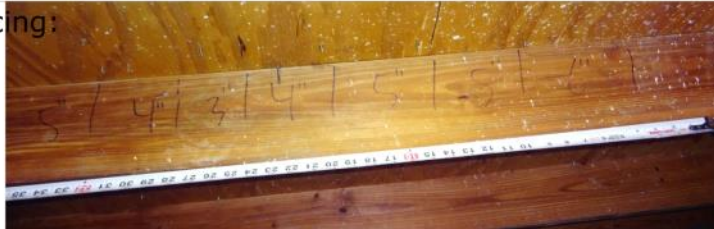
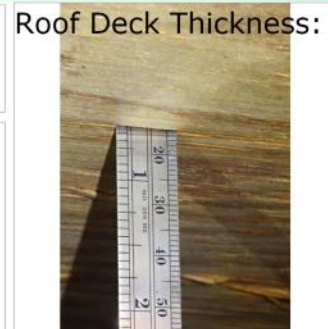
Roof Deck Thickness:

Underside of roof is in good condition

- ☒ C. Plywood/OSB roof sheathing with a minimum thickness of 7/16" inch attached to the roof truss/rafter (spaced a maximum of 24" inches o.c.) by 8d common nails spaced a maximum of 6" inches in the field. -OR- Dimensional lumber/Tongue Groove decking with a minimum of 2 nails per board (or 1 nail per board if each board is equal to or less than 6 inches in width). -OR- Any system of screws, nails, adhesives, other deck fastening system or truss/rafter spacing that is shown to have an equivalent
