1825-1831 Clearbrooke Wind Mitigation

Wind Mitigation Inspection Report

By: Fair Wind Inspections Inc.

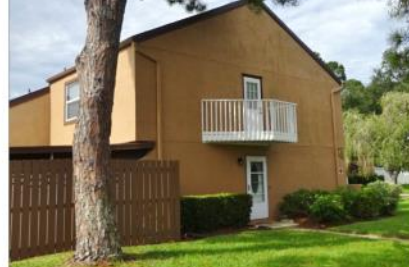
Geometry Picture

Roof Geometry: Non-Hip
Total Non-Hip: N/A Total Perimeter: N/A
Less Than 2:12: N/A Total Area: N/A

Gable end walls and/or non-hip features are greater than 10% of total perimeter

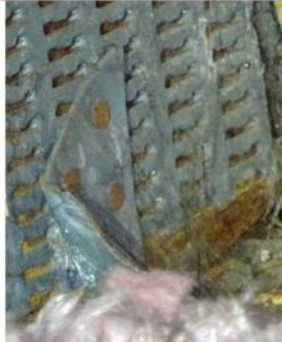
Roof to Wall Attachment:

- ☒ B. Clips
 - ☒ Metal connectors that do not wrap over the top of the truss/rafter, **or**
 - ☒ Metal connectors with a minimum of 1 strap that wraps over the top of the truss/rafter and does not meet the nail position requirements of C or D, but is secured with a minimum of 3 nails.

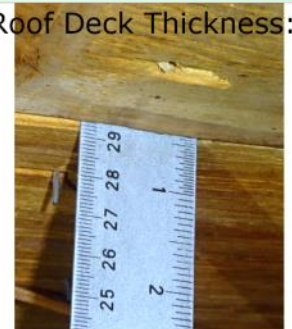
Roof Deck Thickness:

Underside of roof is in good condition

- ☒ C. Plywood/OSB roof sheathing with a minimum thickness of 7/16" inch attached to the roof truss/rafter (spaced a maximum of 24" inches o.c.) by 8d common nails spaced a maximum of 6" inches in the field. -OR- Dimensional lumber/Tongue Groove decking with a minimum of 2 nails per board (or 1 nail per board if each board is equal to or less than 6 inches in width). -OR- Any system of screws, nails, adhesives, other deck fastening system or truss/rafter spacing that is shown to have an equivalent
