# Clearbrooke Townhouse Condos 1826-1832

## Wind Mitigation Inspection Report

By: Fair Wind Inspections Inc.

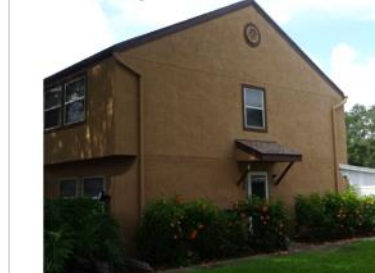
Geometry Picture

Roof Geometry: Non-Hip  
 Total Non-Hip: N/A Total Perimeter: N/A  
 Less Than 2:12: N/A Total Area: N/A

Gable end walls and/or non-hip features are greater than 10% of total perimeter

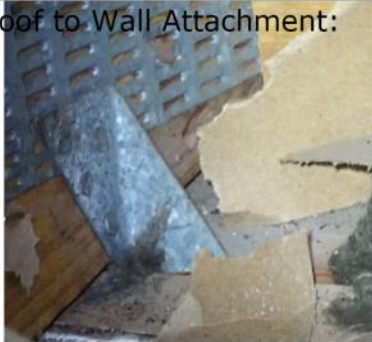
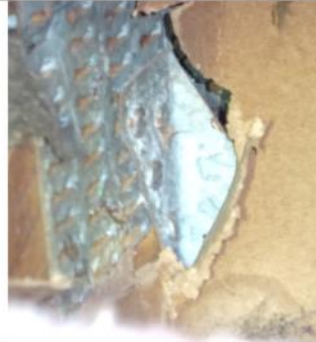
Roof to Wall Attachment:

- ☒ Secured to truss/rafter with a minimum of three (3) nails, **and**
- ☒ Attached to the wall top plate of the wall framing, or embedded in the bond beam, with less than a 1/2" gap from the blocking or truss/rafter and blocked no more than 1.5" of the truss/rafter, and free of visible severe corrosion.
- ☒ B. Clips
  - ☒ Metal connectors that do not wrap over the top of the truss/rafter, **or**
  - ☒ Metal connectors with a minimum of 1 strap that wraps over the top of the truss/rafter and does not meet the nail position requirements of C or D, but is secured with a minimum of 3 nails.
- ☐ C. Single Wraps

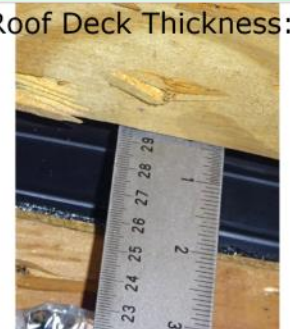
Roof Deck Thickness:

Underside of roof is in good condition

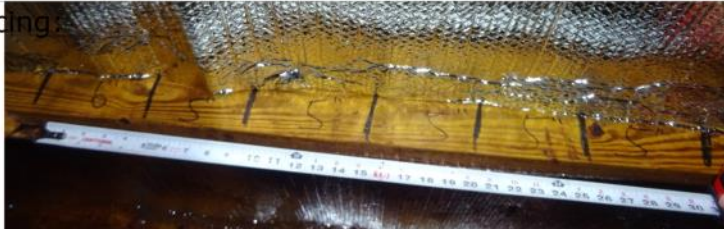
Nail Spacing:

- ☒ C. Plywood/OSB roof sheathing with a minimum thickness of 7/16" inch attached to the roof truss/rafter (spaced a maximum of 24" inches o.c.) by 8d common nails spaced a maximum of 6" inches in the field. -OR- Dimensional lumber/Tongue Groove decking with a minimum of 2 nails per board (or 1 nail per board if each board is equal to or less than 6 inches in width). -OR- Any system of screws, nails, adhesives, other deck fastening system or truss/rafter spacing that is shown to have an equivalent
