1833-1839 Clearbrooke Wind Mitigation

Wind Mitigation Inspection Report

By: Fair Wind Inspections Inc.

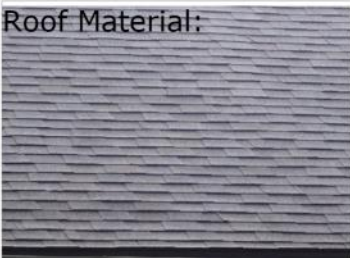
Roof Material:

Date Replaced: March 12, 2018
Permit With: Pinellas County
Permit Number: PER-H-CW18-03352
Covering: Shingles

Roof surface is in good condition

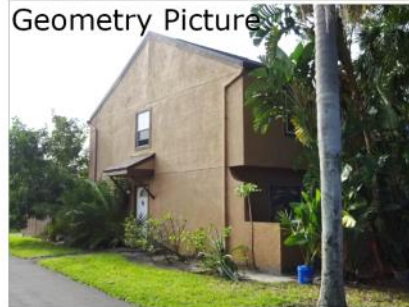
Geometry Picture

Roof Geometry: Non-Hip

Gable end walls and/or non-hip features are greater than 10% of total perimeter

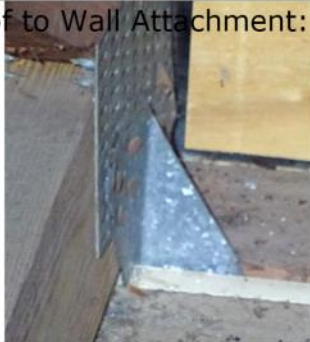
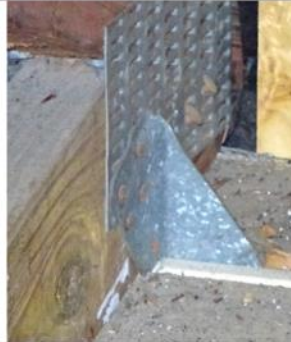
Roof to Wall Attachment:

- ☒ B. Clips
 - ☒ Metal connectors that do not wrap over the top of the truss/rafter, **or**
 - ☒ Metal connectors with a minimum of 1 strap that wraps over the top of the truss/rafter and does not meet the nail position requirements of C or D, but is secured with a minimum of 3 nails.

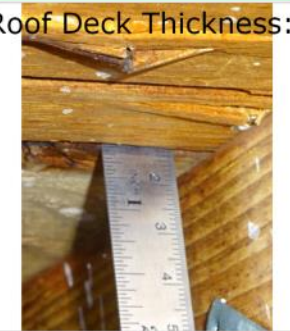
Roof Deck Thickness:

Underside of roof is in good condition

- ☒ C. Plywood/OSB roof sheathing with a minimum thickness of 7/16" inch attached to the roof truss/rafter (spaced a maximum of 24" inches o.c.) by 8d common nails spaced a maximum of 6" inches in the field. -OR- Dimensional lumber/Tongue Groove decking with a minimum of 2 nails per board (or 1 nail per board if each board is equal to or less than 6 inches in width). -OR- Any system of screws, nails, adhesives, other deck fastening system or truss/rafter spacing that is shown to have an equivalent
