1834-1840 Clearbrooke Wind Mitigation

Wind Mitigation Inspection Report

By: Fair Wind Inspections Inc.

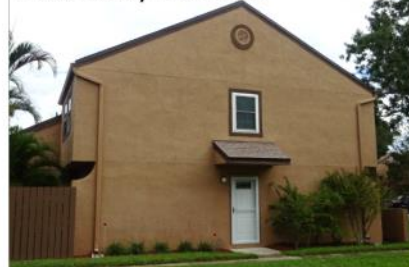
Geometry Picture

Roof Geometry: Non-Hip
Total Non-Hip: N/A Total Perimeter: N/A
Less Than 2:12: N/A Total Area: N/A

Gable end walls and/or non-hip features are greater than 10% of total perimeter

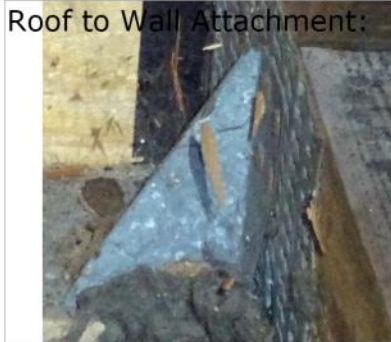
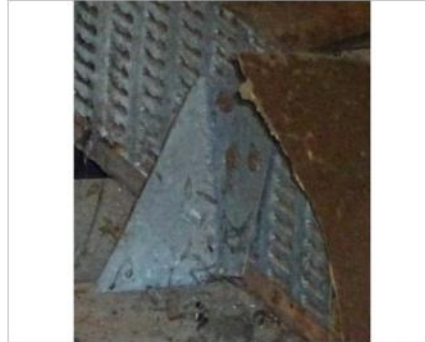
Roof to Wall Attachment:

- ☒ Secured to truss/rafter with a minimum of three (3) nails, **and**
- ☒ Attached to the wall top plate of the wall framing, or embedded in the bond beam, with less than a 1/2" gap from the blocking or truss/rafter and blocked no more than 1.5" of the truss/rafter, and free of visible severe corrosion.

- ☒ B. Clips
 - ☒ Metal connectors that do not wrap over the top of the truss/rafter, **or**
 - ☒ Metal connectors with a minimum of 1 strap that wraps over the top of the truss/rafter and does not meet the nail position requirements of C or D, but is secured with a minimum of 3 nails.

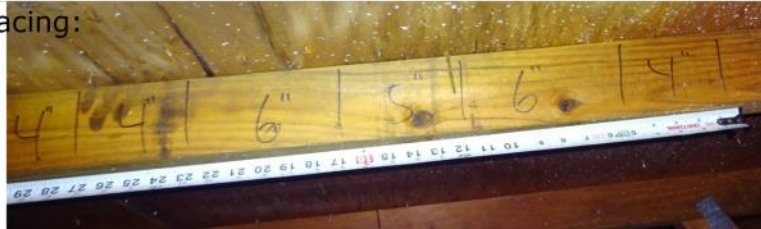
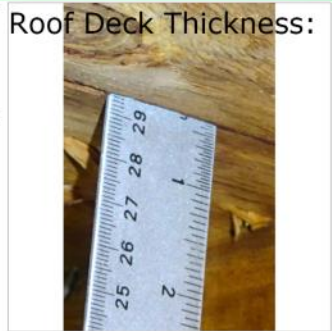
Roof Deck Thickness:

Underside of roof is in good condition

- ☒ C. Plywood/OSB roof sheathing with a minimum thickness of 7/16" inch attached to the roof truss/rafter (spaced a maximum of 24" inches o.c.) by 8d common nails spaced a maximum of 6" inches in the field. -OR- Dimensional lumber/Tongue Groove decking with a minimum of 2 nails per board (or 1 nail per board if each board is equal to or less than 6 inches in width). -OR- Any system of screws, nails, adhesives, other deck fastening system or truss/rafter spacing that is shown to have an equivalent
