# Clearbrooke Townhouse Condos 1841-1847

## Wind Mitigation Inspection Report

By: Fair Wind Inspections Inc.

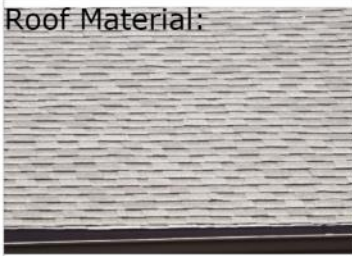
Roof Material:

Date Replaced: May 18, 2021  
Permit With: Pinellas County  
Permit Number: EBP-21-08822  
Covering: Shingles

Roof surface is in good condition

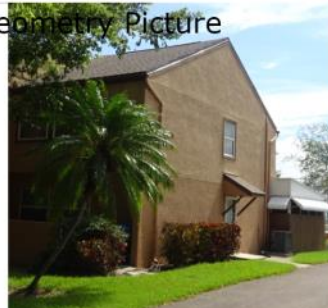
Geometry Picture

Roof Geometry: Non-Hip  
Total Non-Hip: N/A Total Perimeter: N/A  
Less Than 2:12: N/A Total Area: N/A

Gable end walls and/or non-hip features are greater than 10% of total perimeter

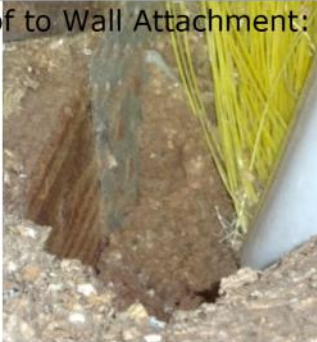
Roof to Wall Attachment:

- ☒ B. Clips
  - ☒ Metal connectors that do not wrap over the top of the truss/rafter, **or**
  - ☒ Metal connectors with a minimum of 1 strap that wraps over the top of the truss/rafter and does not meet the nail position requirements of C or D, but is secured with a minimum of 3 nails.

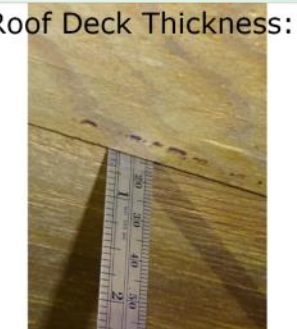
Roof Deck Thickness:

Underside of roof is in good condition

- ☒ C. Plywood/OSB roof sheathing with a minimum thickness of 7/16" inch attached to the roof truss/rafter (spaced a maximum of 24" inches o.c.) by 8d common nails spaced a maximum of 6" inches in the field. -OR- Dimensional lumber/Tongue Groove decking with a minimum of 2 nails per board (or 1 nail per board if each board is equal to or less than 6 inches in width). -OR- Any system of screws, nails, adhesives, other deck fastening system or truss/rafter spacing that is shown to have an equivalent
