Clearbrooke Townhouse Condos Wind Mitigation

Wind Mitigation Inspection Report

By: Fair Wind Inspections Inc.

Date/Time: 7/27/2021 10-12 PM
First Name: Clearbrooke
Last Name: Townhouse Condos
Contact Number:
Contact Number:
E-mail:
Address: 1849-1855 Clearbrooke Dri
City: Clearwater
State: FL
Zip: 33760
County: Pinellas
Advertiser:
Referred By: Watertight Roofing

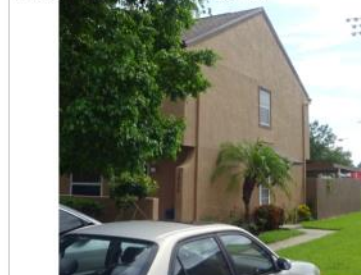
Geometry Picture

Roof Geometry: Non-Hip
Total Non-Hip: N/A Total Perimeter: N/A
Less Than 2:12: N/A Total Area: N/A

Gable end walls and/or non-hip features are greater than 10% of total perimeter

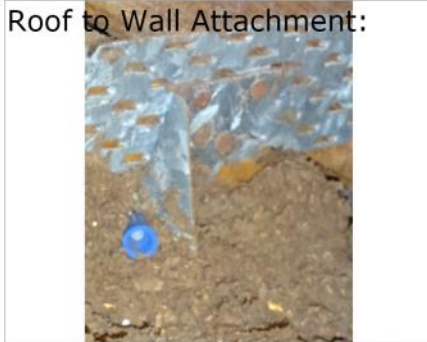
Roof to Wall Attachment:

- ☒ Secured to truss/rafter with a minimum of three (3) nails, **and**
- ☒ Attached to the wall top plate of the wall framing, or embedded in the bond beam, with less than a 1/2" gap from the blocking or truss/rafter and blocked no more than 1.5" of the truss/rafter, and free of visible severe corrosion.

- ☒ B. Clips
 - ☒ Metal connectors that do not wrap over the top of the truss/rafter, **or**
 - ☒ Metal connectors with a minimum of 1 strap that wraps over the top of the truss/rafter and does not meet the nail position requirements of C or D, but is secured with a minimum of 3 nails.

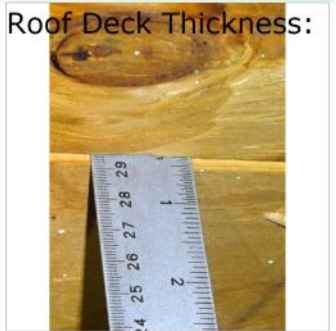
Roof Deck Thickness:

Underside of roof is in good condition

- ☒ C. Plywood/OSB roof sheathing with a minimum thickness of 7/16" inch attached to the roof truss/rafter (spaced a maximum of 24" inches o.c.) by 8d common nails spaced a maximum of 6" inches in the field. -OR- Dimensional lumber/Tongue Groove decking with a minimum of 2 nails per board (or 1 nail per board if each board is equal to or less than 6 inches in width). -OR- Any system of screws, nails, adhesives, other deck fastening system or truss/rafter spacing that is shown to have an equivalent
