1850-1856 Clearbrooke Wind Mitigation

Wind Mitigation Inspection Report

By: Fair Wind Inspections Inc.

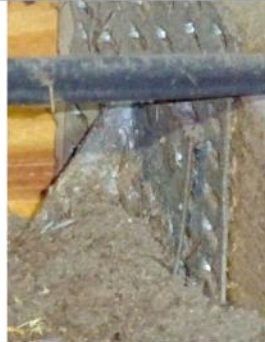
Roof to Wall Attachment:

- ☒ B. Clips
 - ☒ Metal connectors that do not wrap over the top of the truss/rafter, **or**
 - ☒ Metal connectors with a minimum of 1 strap that wraps over the top of the truss/rafter and does not meet the nail position requirements of C or D, but is secured with a minimum of 3 nails.

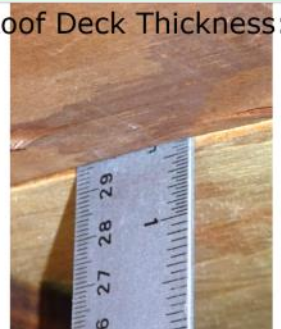
Roof Deck Thickness:

Underside of roof is in good condition

- ☒ C. Plywood/OSB roof sheathing with a minimum thickness of 7/16" inch attached to the roof truss/rafter (spaced a maximum of 24" inches o.c.) by 8d common nails spaced a maximum of 6" inches in the field. -OR- Dimensional lumber/Tongue Groove decking with a minimum of 2 nails per board (or 1 nail per board if each board is equal to or less than 6 inches in width). -OR- Any system of screws, nails, adhesives, other deck fastening system or truss/rafter spacing that is shown to have an equivalent
