# 1857-1863 Clearbrooke Wind Mitigation

## Wind Mitigation Inspection Report

By: Fair Wind Inspections Inc.

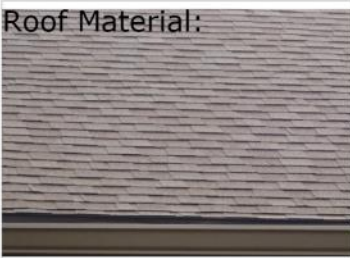
Roof Material:

Date Replaced: Sept 27, 2019  
Permit With: Pinellas County  
Permit Number: PER-H-CW19-13709  
Covering: Shingles

Roof surface is in good condition

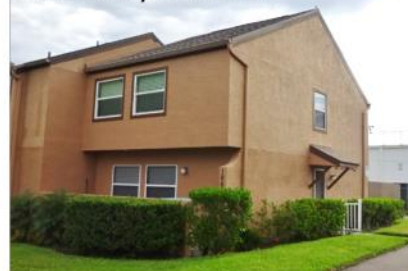
Geometry Picture

Roof Geometry: Non-Hip  
Total Non-Hip: N/A Total Perimeter: N/A  
Less Than 2:12: N/A Total Area: N/A

Gable end walls and/or non-hip features are greater than 10% of total perimeter

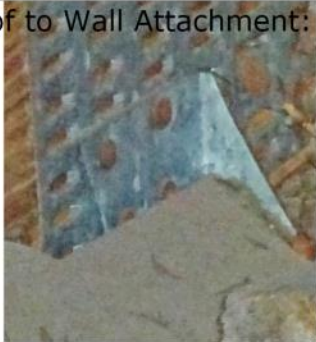
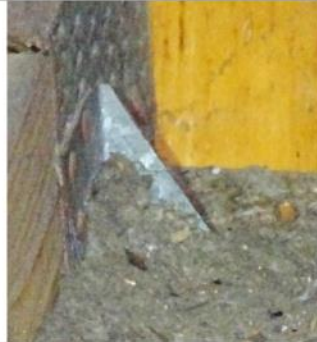
Roof to Wall Attachment:

- ☒ B. Clips
  - ☒ Metal connectors that do not wrap over the top of the truss/rafter, **or**
  - ☒ Metal connectors with a minimum of 1 strap that wraps over the top of the truss/rafter and does not meet the nail position requirements of C or D, but is secured with a minimum of 3 nails.

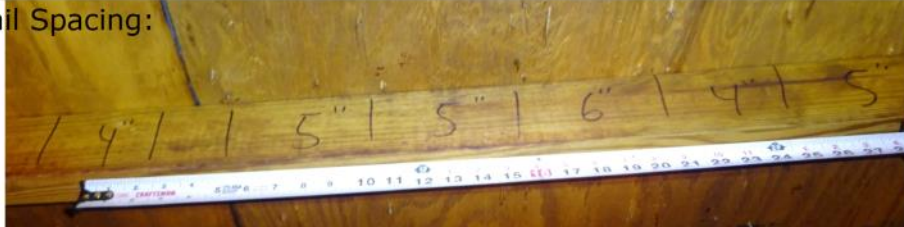
Underside of roof is in good condition

- ☒ C. Plywood/OSB roof sheathing with a minimum thickness of 7/16" inch attached to the roof truss/rafter (spaced a maximum of 24" inches o.c.) by 8d common nails spaced a maximum of 6" inches in the field. -OR- Dimensional lumber/Tongue Groove decking with a minimum of 2 nails per board (or 1 nail per board if each board is equal to or less than 6 inches in width). -OR- Any system of screws, nails, adhesives, other deck fastening system or truss/rafter spacing that is shown to have an equivalent
