# 1858-1864 Clearbrooke Wind Mitigation

## Wind Mitigation Inspection Report

By: Fair Wind Inspections Inc.

Date/Time: 5/3/2022 8-10 AM  
First Name: Clearbrooke  
Last Name: Townhouse Condos  
Contact Number:  
Contact Number:  
E-mail:  
Address: 1858-1864 Clearbrooke Dr  
City: Clearwater  
State: FL  
Zip: 33760  
County: Pinellas  
Advertiser: Previous Customer  
Referred By:

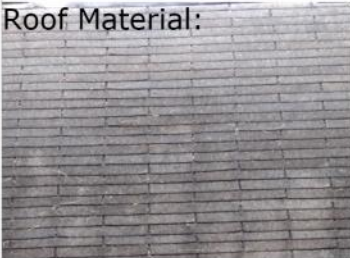
Roof Material:

Date Replaced: Unknown  
Permit With: n/a  
Permit Number: n/a  
Covering: Shingles

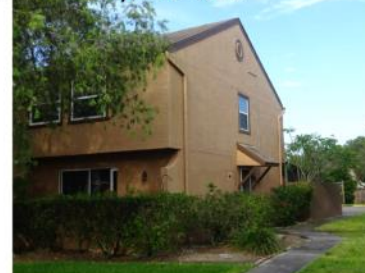
Geometry Picture

Roof Geometry: Non-Hip  
Total Non-Hip: N/A Total Perimeter: N/A  
Less Than 2:12: N/A Total Area: N/A

Gable end walls and/or non-hip features are greater than 10% of total perimeter

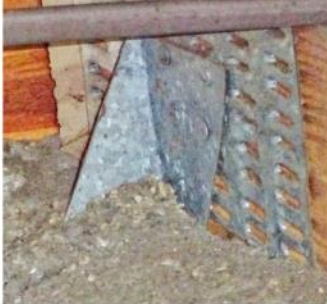
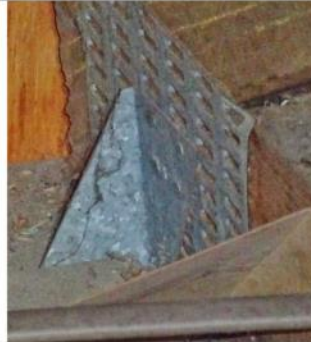
Roof to Wall Attachment:

- ☒ Secured to truss/rafter with a minimum of three (3) nails, **and**
- ☒ Attached to the wall top plate of the wall framing, or embedded in the bond beam, with less than a 1/2" gap from the blocking or truss/rafter and blocked no more than 1.5" of the truss/rafter, and free of visible severe corrosion.
- ☒ B. Clips
  - ☒ Metal connectors that do not wrap over the top of the truss/rafter, **or**
  - ☒ Metal connectors with a minimum of 1 strap that wraps over the top of the truss/rafter and does not meet the nail position requirements of C or D, but is secured with a minimum of 3 nails.
- ☐ C. Single Wraps

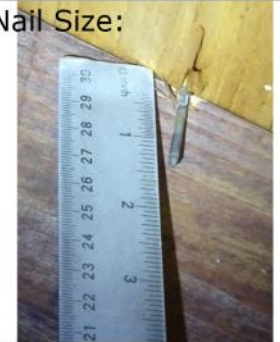
Nail Size:

Underside of roof is in good condition

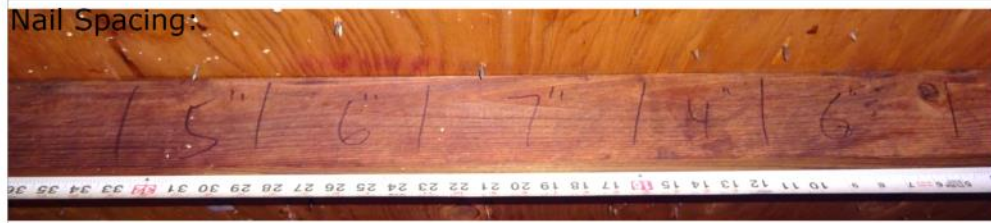
Nail Spacing:

- ☒ A. Plywood/Oriented strand board (OSB) roof sheathing attached to the roof truss/rafter (spaced a maximum of 24" inches o.c.) by staples or 6d nails spaced at 6" along the edge and 12" in the field. -OR- Batten decking supporting wood shakes or wood shingles. -OR- Any system of screws, nails, adhesives, other deck fastening system or truss/rafter spacing that has an equivalent mean uplift less than that required for Options B or C below.
