1866-1872 Clearbrooke Wind Mitigation

Wind Mitigation Inspection Report

By: Fair Wind Inspections Inc.

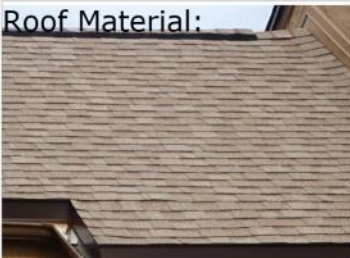
Roof Material:

Date Replaced: Oct 12, 2018
Permit With: Pinellas County
Permit Number: PER-H-CW18-13904
Covering: Shingles

Roof surface is in good condition

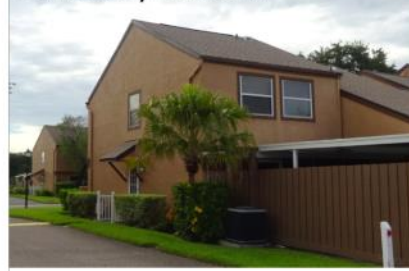
Geometry Picture

Roof Geometry: Non-Hip
Total Non-Hip: N/A Total Perimeter: N/A
Less Than 2:12: N/A Total Area: N/A

Gable end walls and/or non-hip features are greater than 10% of total perimeter

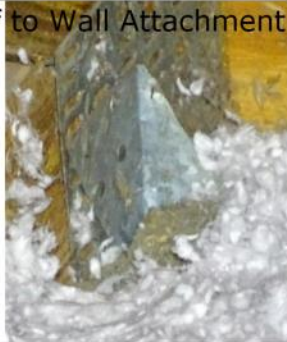
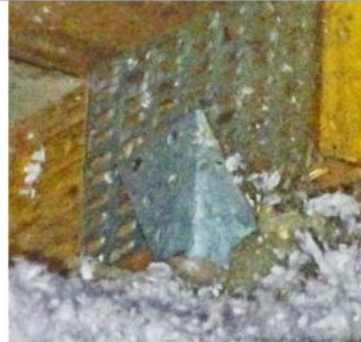
Roof to Wall Attachment:

- ☒ Secured to truss/rafter with a minimum of three (3) nails, **and**
- ☒ Attached to the wall top plate of the wall framing, or embedded in the bond beam, with less than a 1/2" gap from the blocking or truss/rafter and blocked no more than 1.5" of the truss/rafter, and free of visible severe corrosion.

- ☒ B. Clips
 - ☒ Metal connectors that do not wrap over the top of the truss/rafter, **or**
 - ☒ Metal connectors with a minimum of 1 strap that wraps over the top of the truss/rafter and does not meet the nail position requirements of C or D, but is secured with a minimum of 3 nails.

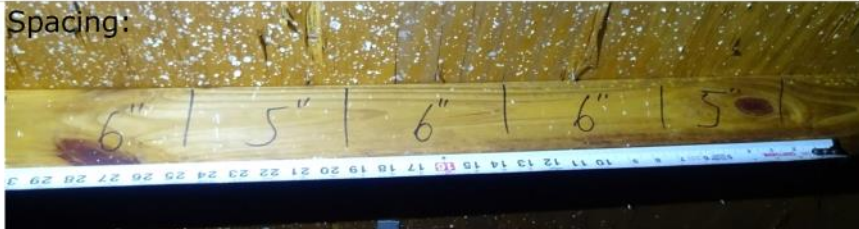
Nail Spacing:

- ☒ C. Plywood/OSB roof sheathing with a minimum thickness of 7/16" inch attached to the roof truss/rafter (spaced a maximum of 24" inches o.c.) by 8d common nails spaced a maximum of 6" inches in the field. -OR- Dimensional lumber/Tongue Groove decking with a minimum of 2 nails per board (or 1 nail per board if each board is equal to or less than 6 inches in width). -OR- Any system of screws, nails, adhesives, other deck fastening system or truss/rafter spacing that is shown to have an equivalent
