1873-1879 Clearbrooke Wind Mitigation

Wind Mitigation Inspection Report

By: Fair Wind Inspections Inc.

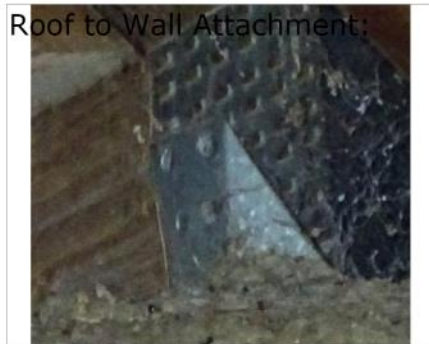
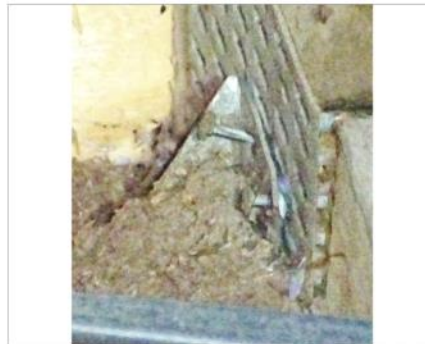
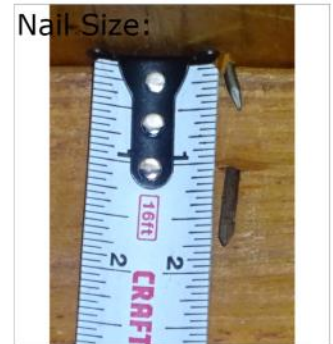
Clip Type:
 Nails Per Clip:

- ☒ Secured to truss/rafter with a minimum of three (3) nails, **and**
- ☒ Attached to the wall top plate of the wall framing, or embedded in the bond beam, with less than a 1/2" gap from the blocking or truss/rafter and blocked no more than 1.5" of the truss/rafter, and free of visible severe corrosion.

- ☒ B. Clips
 - ☒ Metal connectors that do not wrap over the top of the truss/rafter, **or**
 - ☒ Metal connectors with a minimum of 1 strap that wraps over the top of the truss/rafter and does not meet the nail position requirements of C or D, but is secured with a minimum of 3 nails.

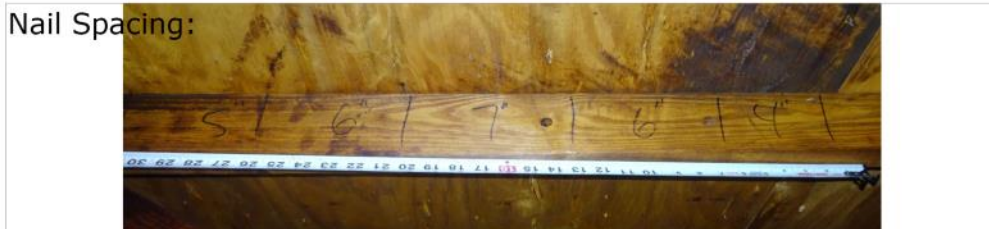
Roof Deck Thickness:

Underside of roof is in good condition
