Clearbrooke Townhouse Condos 1874-1880

Wind Mitigation Inspection Report

By: Fair Wind Inspections Inc.

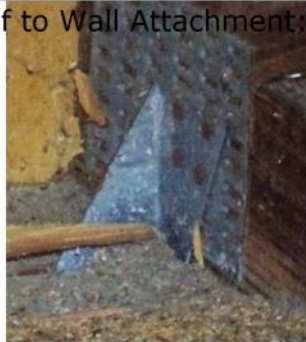
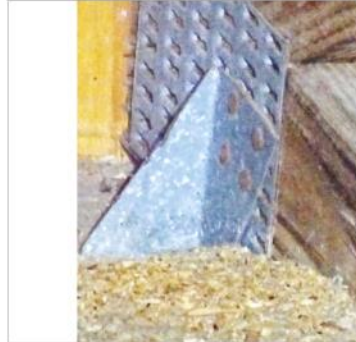
Roof to Wall Attachment:

- ☒ B. Clips
 - ☒ Metal connectors that do not wrap over the top of the truss/rafter, **or**
 - ☒ Metal connectors with a minimum of 1 strap that wraps over the top of the truss/rafter and does not meet the nail position requirements of C or D, but is secured with a minimum of 3 nails.

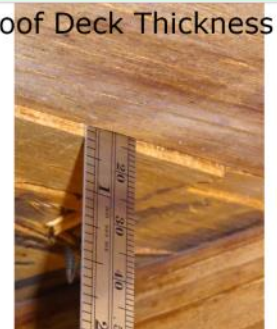
Roof Deck Thickness:

Underside of roof is in good condition

- ☒ C. Plywood/OSB roof sheathing with a minimum thickness of 7/16" inch attached to the roof truss/rafter (spaced a maximum of 24" inches o.c.) by 8d common nails spaced a maximum of 6" inches in the field. -OR- Dimensional lumber/Tongue Groove decking with a minimum of 2 nails per board (or 1 nail per board if each board is equal to or less than 6 inches in width). -OR- Any system of screws, nails, adhesives, other deck fastening system or truss/rafter spacing that is shown to have an equivalent
