1881-1887 Clearbrooke Wind Mitigation

Wind Mitigation Inspection Report

By: Fair Wind Inspections Inc.

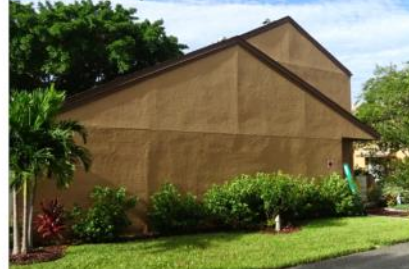
Geometry Picture

Roof Geometry: Non-Hip
Total Non-Hip: N/A Total Perimeter: N/A
Less Than 2:12: N/A Total Area: N/A

Gable end walls and/or non-hip features are greater than 10% of total perimeter

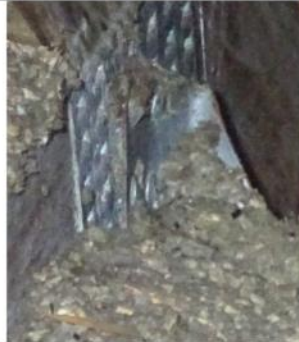
Roof to Wall Attachment:

- ☒ B. Clips
 - ☒ Metal connectors that do not wrap over the top of the truss/rafter, **or**
 - ☒ Metal connectors with a minimum of 1 strap that wraps over the top of the truss/rafter and does not meet the nail position requirements of C or D, but is secured with a minimum of 3 nails.

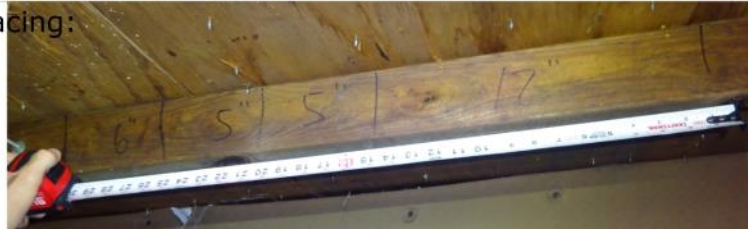
Nail Spacing:

Underside of roof is in good condition

- ☒ A. Plywood/Oriented strand board (OSB) roof sheathing attached to the roof truss/rafter (spaced a maximum of 24" inches o.c.) by staples or 6d nails spaced at 6" along the edge and 12" in the field. -OR- Batten decking supporting wood shakes or wood shingles. -OR- Any system of screws, nails, adhesives, other deck fastening system or truss/rafter spacing that has an equivalent mean uplift less than that required for Options B or C below.
