# 1882-1888 Clearbrooke Wind Mitigation

## Wind Mitigation Inspection Report

By: Fair Wind Inspections Inc.

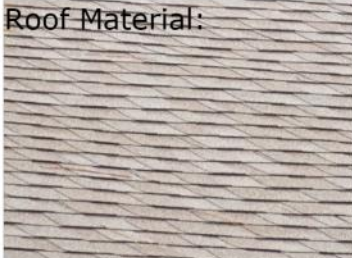
Roof Material:

Date Replaced: Nov 12, 2014  
Permit With: Pinellas County  
Permit Number: PER-H-CB14-08078  
Covering: Shingles

Roof surface is in good condition

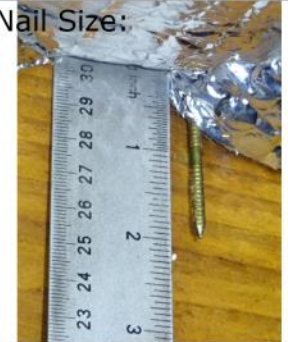
Roof to Wall Attachment:

- ☒ Secured to truss/rafter with a minimum of three (3) nails, **and**
- ☒ Attached to the wall top plate of the wall framing, or embedded in the bond beam, with less than a 1/2" gap from the blocking or truss/rafter and blocked no more than 1.5" of the truss/rafter, and free of visible severe corrosion.

- ☒ B. Clips
  - ☒ Metal connectors that do not wrap over the top of the truss/rafter, **or**
  - ☒ Metal connectors with a minimum of 1 strap that wraps over the top of the truss/rafter and does not meet the nail position requirements of C or D, but is secured with a minimum of 3 nails.

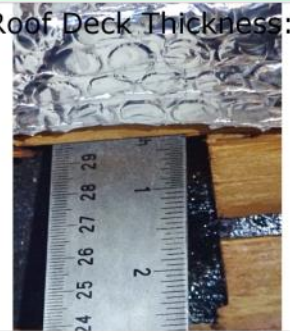
Roof Deck Thickness:

Underside of roof is in good condition

- ☒ C. Plywood/OSB roof sheathing with a minimum thickness of 7/16" inch attached to the roof truss/rafter (spaced a maximum of 24" inches o.c.) by 8d common nails spaced a maximum of 6" inches in the field. -OR- Dimensional lumber/Tongue Groove decking with a minimum of 2 nails per board (or 1 nail per board if each board is equal to or less than 6 inches in width). -OR- Any system of screws, nails, adhesives, other deck fastening system or truss/rafter spacing that is shown to have an equivalent
