# 1889-1895 Clearbrooke Wind Mitigation

## Wind Mitigation Inspection Report

By: Fair Wind Inspections Inc.

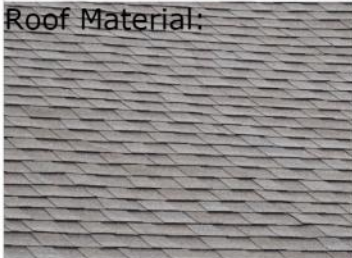
Roof Material:

Date Replaced: July 23, 2015  
Permit With: Pinellas County  
Permit Number: PER-H-CW15-07719  
Covering: Shingles

Roof surface is in good condition

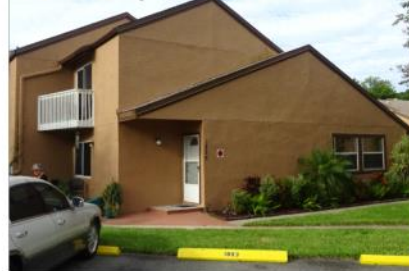
Geometry Picture

Roof Geometry: Non-Hip  
Total Non-Hip: N/A Total Perimeter: N/A  
Less Than 2:12: N/A Total Area: N/A

Gable end walls and/or non-hip features are greater than 10% of total perimeter

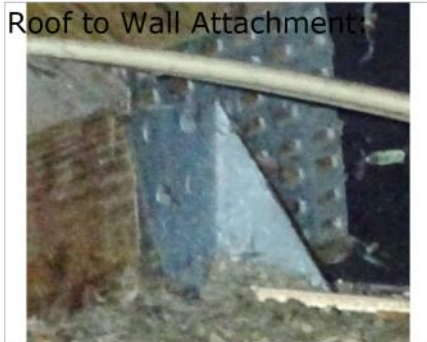
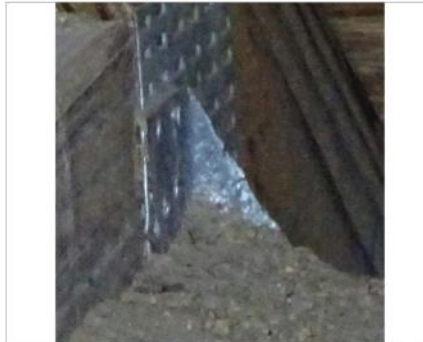
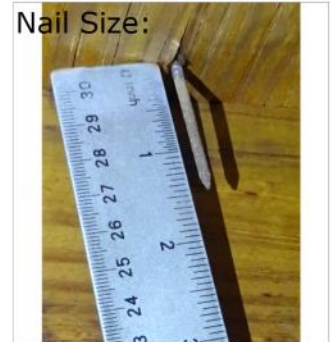
Clip Type:   
 Nails Per Clip:

- ☒ Secured to truss/rafter with a minimum of three (3) nails, **and**
- ☒ Attached to the wall top plate of the wall framing, or embedded in the bond beam, with less than a 1/2" gap from the blocking or truss/rafter and blocked no more than 1.5" of the truss/rafter, and free of visible severe corrosion.
- ☒ B. Clips
  - ☒ Metal connectors that do not wrap over the top of the truss/rafter, **or**
  - ☒ Metal connectors with a minimum of 1 strap that wraps over the top of the truss/rafter and does not meet the nail position requirements of C or D, but is secured with a minimum of 3 nails.
- ☐ C. Single Wraps

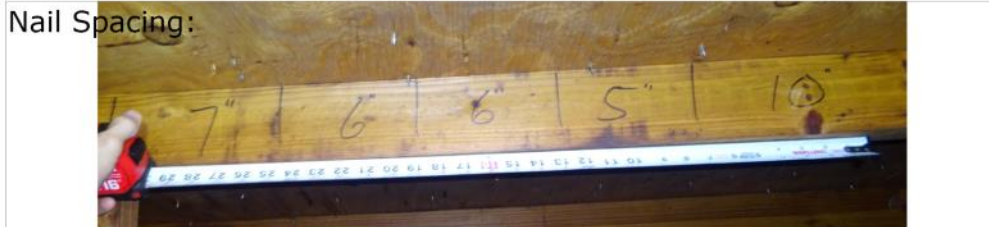
Deck Thickness:   
 Nail Size:   
 Nail Spacing:

- ☒ C. Plywood/OSB roof sheathing with a minimum thickness of 7/16" inch attached to the roof truss/rafter (spaced a maximum of 24" inches o.c.) by 8d common nails spaced a maximum of 6" inches in the field. -OR- Dimensional lumber/Tongue Groove decking with a minimum of 2 nails per board (or 1 nail per board if each board is equal to or less than 6 inches in width). -OR- Any system of screws, nails, adhesives, other deck fastening system or truss/rafter spacing that is shown to have an equivalent
