Clearbrooke Townhouse Condos 1842-1848

Wind Mitigation Inspection Report

By: Fair Wind Inspections Inc.

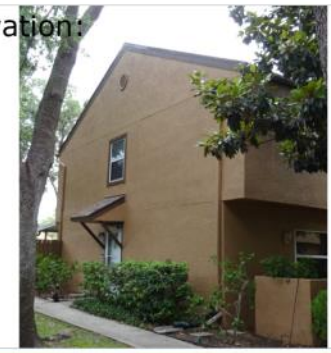
Left Elevation:

Roof surface is in good condition

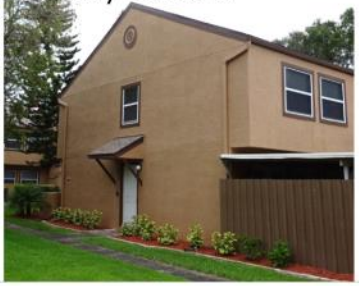
Geometry Picture

Roof Geometry: Non-Hip

Gable end walls and/or non-hip features are greater than 10% of total perimeter

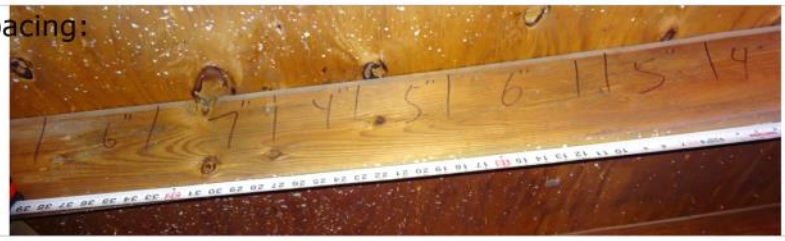
Clip Type:	Toe Nails
Nails Per Clip:	2

Notes: Clip or strap only has 1-2 nails, thus must classify as a toe nail system.

Deck Thickness:	1/2" Plywood
Nail Size:	8d Ring Shank
Nail Spacing:	6" or less

Underside of roof is in good condition
